## Chapter 9

# FIRE BEHAVIOR IN WORLD TRADE CENTER 2

### 9.1 INTRODUCTION

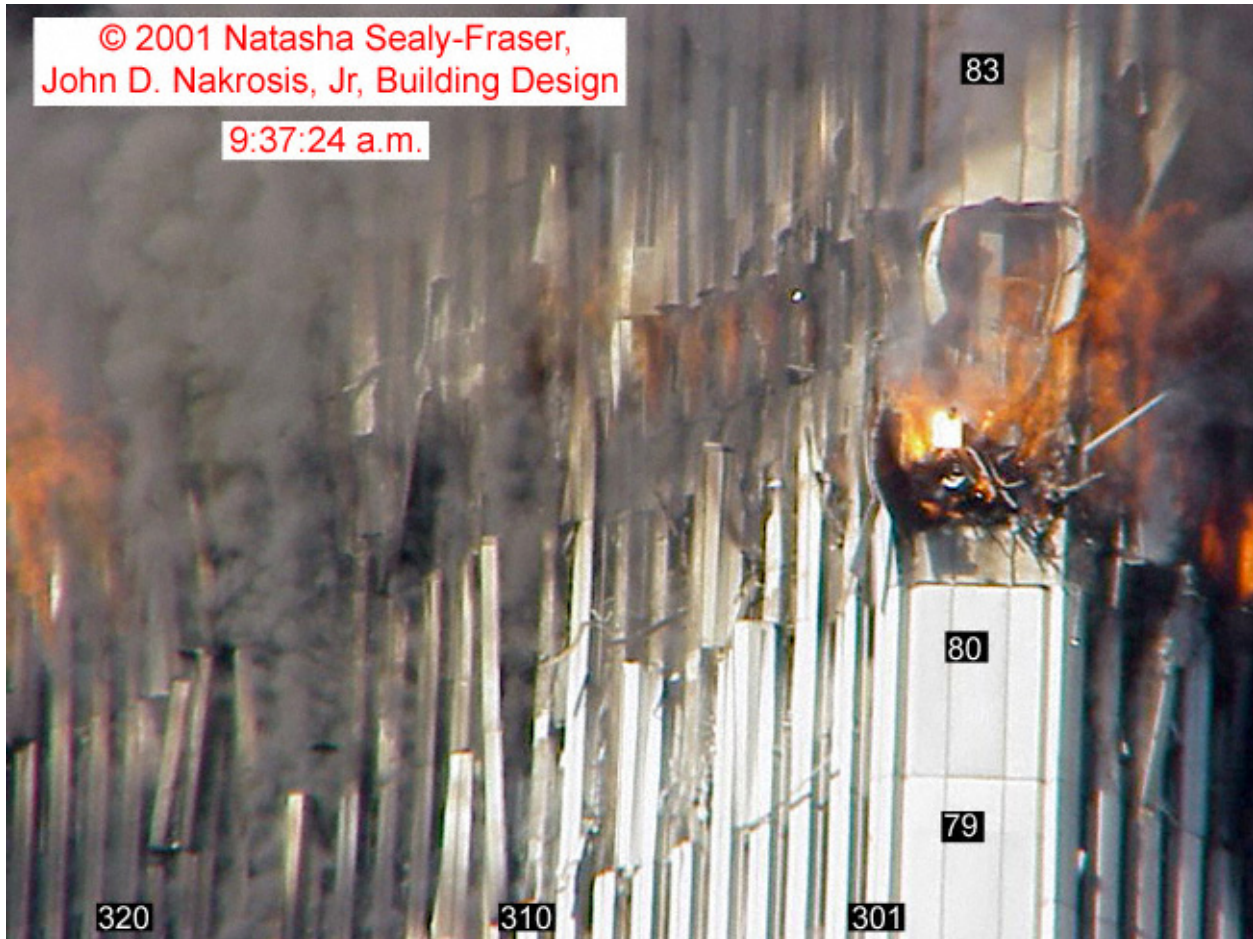
Figure 9-45 shows the northeast corner of the tower. The bright flame in the 81st floor corner opening, which has been attributed to metal combustion, stands out. A check of the original image shows that the pixels at this location are essentially saturated, providing an indication of how much brighter this flame was than the surrounding flames, which had intensities that were far from saturating the pixels. From this angle, flames are visible extending from the 82nd floor at windows 82-204 to 82-207. These windows appeared to be flame-free at 9:36:14 a.m.

**Figure 9-45. This photograph was taken from the northeast at 9:37:24 a.m. and shows portions of the north and east faces of WTC 2. The intensity levels have been adjusted, and column and floor numbers have been added.**

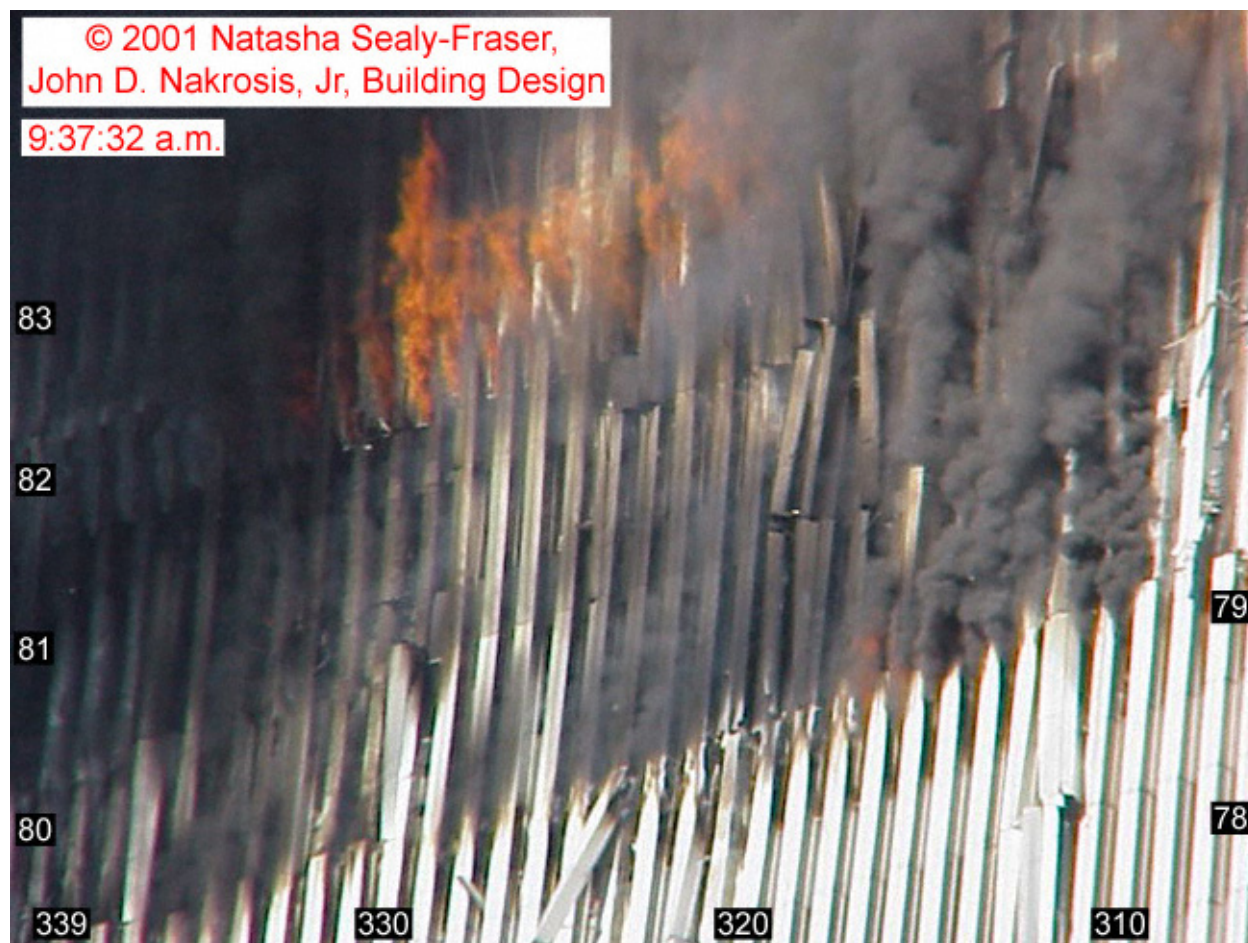
The largest changes in appearance occurred near the center of the east face. In Figure 9-46 the only heavy smoke and flames visible on lower floors is coming from windows 79-310 to 79-317 on the 79th floor. At 9:36:14 a.m. these windows appeared to be free of smoke and fire. On the other hand, the only evidence of the intense fires raging on the 79th floor seconds earlier in windows 79-318 to 79-325 are the carets visible at the tops of the adjacent column covers. Heavy smoke hid much of the upper floor façade in Figure 9-44. The only flames visible on the 82nd floor appeared to be just to the south of column 330. At the later time, large flames are coming from windows 82-320 to 82-333. Recall that intense flames became visible in this region around 9:37:18 a.m.

Closer inspection of Figure 9-46 reveals that the columns on the 80th and 81st floors on either side of column 330 appear to be bowed inward. This bowing could be identified in images taken as early as 9:21:29 a.m. Several additional photographs to be described below show a similar bowing. This indicates that columns on these floors were distorted at least 37 minutes prior to the collapse of the tower.

**Figure 9-46. This photograph was taken from the northeast at 9:37:32 a.m. and shows the center portion of the east face of WTC 2. The intensity levels have been adjusted, and column and floor numbers have been added.**

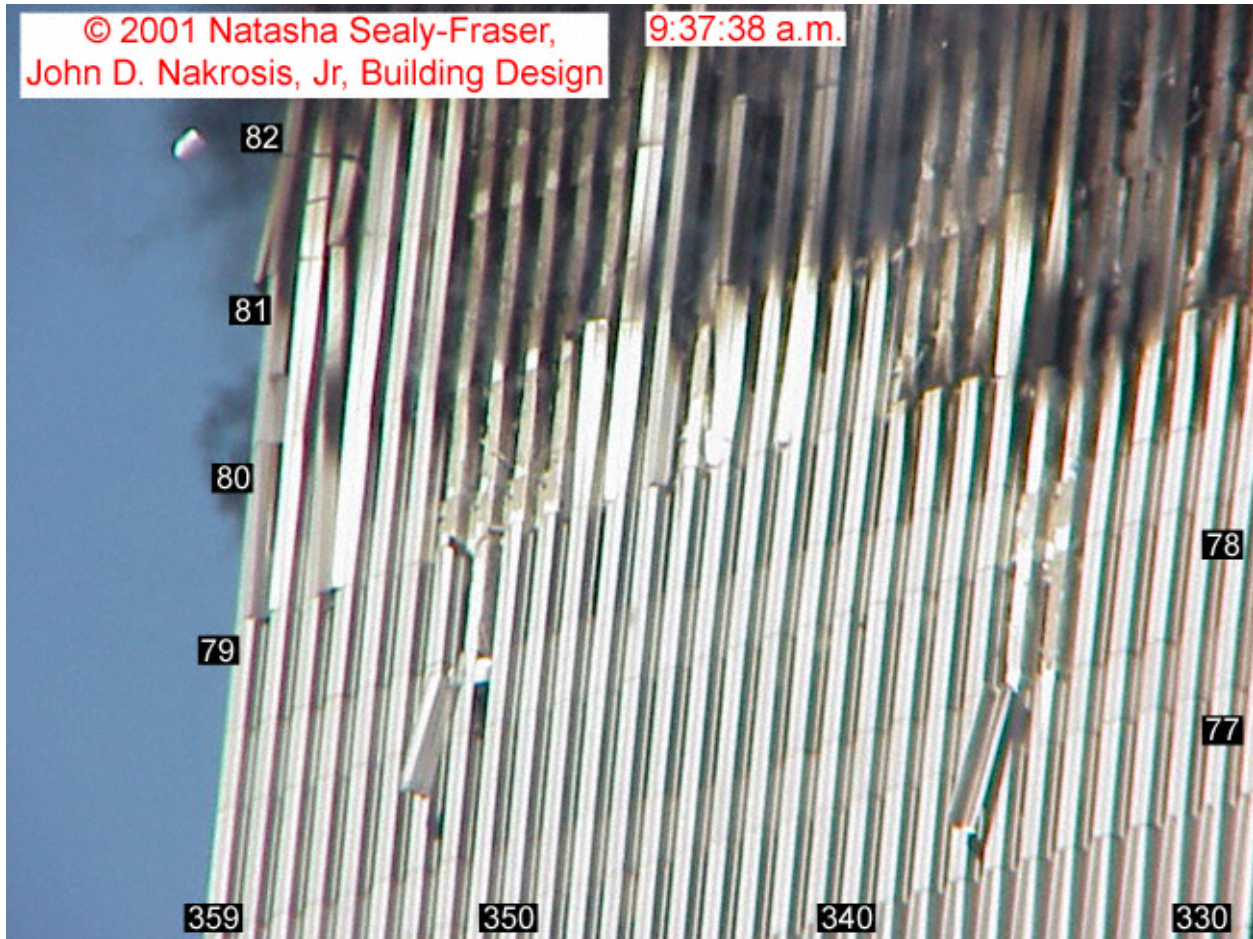
Figure 9-47 show the southern portion of the east face. There is very little smoke and no fire coming from windows in this area. This contrasts sharply with Figure 9-44, in which intense flames and large amounts of smoke were visible coming from numerous windows on the 79th and 80th floors.

**Figure 9-47. This photograph was taken from the northeast at 9:37:32 a.m. and shows the western portion of WTC 2. The intensity levels have been adjusted, and column and floor numbers have been added.**

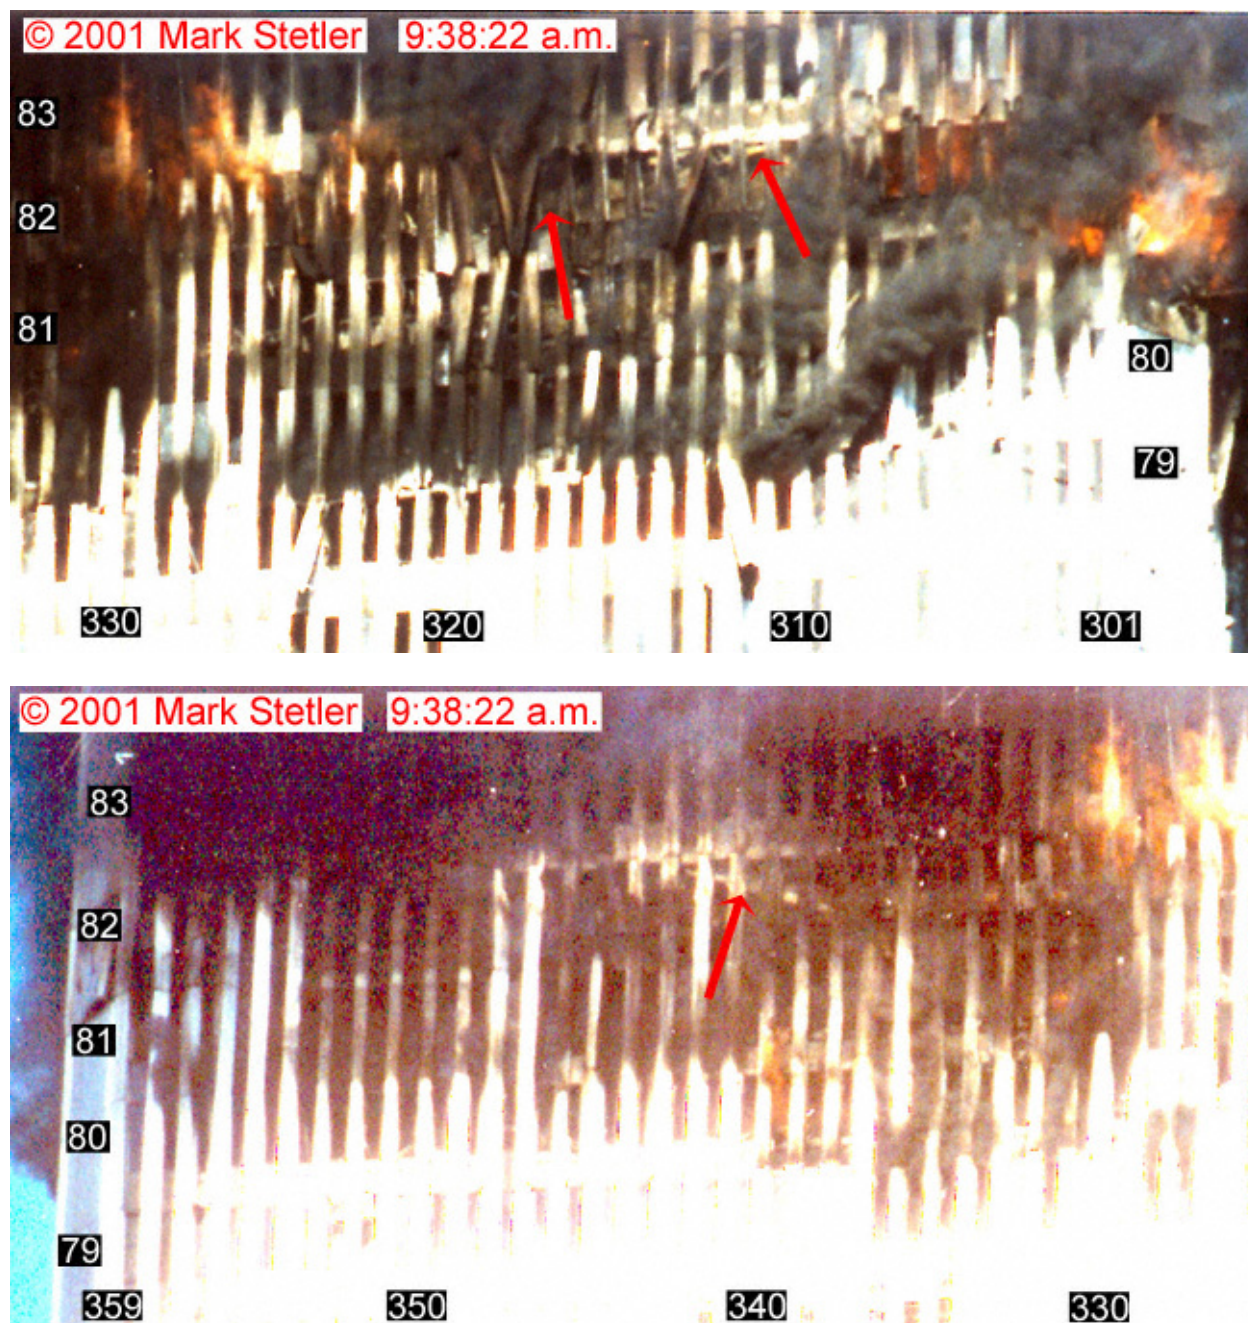
Views of the northern and southern sides of the east face enlarged from the same photograph taken at 9:38:22 a.m. from the east are shown in Figure 9-48. The intensities have been adjusted to overexpose much of the images in order to highlight the object marked with arrows. This is the same hanging object described earlier that has been tentatively identified as the 83rd floor slab. Its appearance has now changed from those seen in Figure 9-1 and Figure 9-2 (9:03:42 a.m.), Figure 9-21 (9:18:38 a.m.), Figure 9-28 (9:27:35 a.m.), Figure 9-31 (9:26:20 a.m.), and Figure 9-40 (9:34:40 a.m.). At these earlier times, the object was visible hanging near the tops of open windows 82-321 to 82-342, even though it did shift downward locally between 9:18:38 a.m. and 9:26:17 a.m. In the bottom image of Figure 9-48, it can still be seen at the top of window 82-342, but now it drops very rapidly and seems to disappear below the base of window 82-337. The object is no longer visible in windows at least as far to the right as window 82-330. Windows immediately to the north of window 82-330 are filled with fire that would hide the object even if it was above the window base.

In the top portion of Figure 9-48, the visible fire area near the center of the 82nd floor ends at window 82-318. Beyond this point, it is possible to see inside the windows again, and the hanging object (marked with arrows) is visible starting near the base of window 82-317 and rising toward the top of window 82-311. This location is 10 windows further north than where the object was seen earlier. These observations suggest that the object, which may have been the 83rd floor slab, that had been hanging near the tops of windows on the 82nd floor since shortly after the aircraft impact sank much lower sometime between 9:34:40 a.m. and 9:38:22 a.m. At some unknown time an additional length of the object became visible on the north side. The fire that had reappeared at the northern edge of the 82nd floor in Figure 9-45 continued to burn at 9:38:22 a.m.

In the top part of Figure 9-48, an extensive fire can be seen on the 79th floor between windows 79-310 and 79-320. There had been indications of a fire in this area prior to the sudden release of smoke and fire (see Figure 9-40). Isolated fires are also visible on the 81st floor at window 81-331 and on the 80th floor at windows 80-338 and 80-339, with flames extended from window 80-339. These latter fires are the only visible remnants of the large fires visible on these floors in Figure 9-43 and Figure 9-44.

**Figure 9-48.** These two images show blow-ups of the north and south sides of the east face of WTC 2 taken from a photograph that was shot at 9:38:22 a.m. The intensities have been adjusted to purposefully overexpose parts of the images. Column and floor numbers have been added

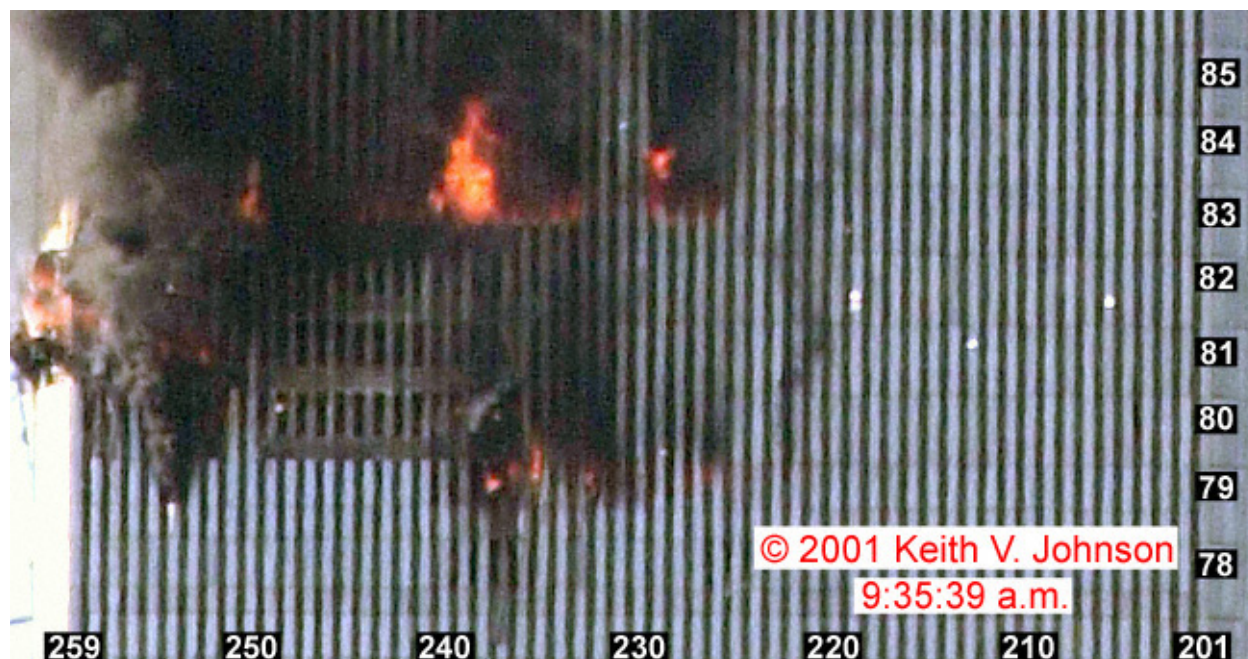
Twenty-one seconds after fire erupted from window 83-226 on the 83rd floor of the north face at 9:33:52 a.m. (see Figure 9-37), window 83-227 opened, and smoke and fire were released. By 9:34:14 a.m. windows 83-228 and 83-229 were also open, and flames were coming from all four windows. A photograph of the area taken at 9:35:39 a.m. is shown in Figure 9-49. The flames in windows 83-226 to 83-229 are visible. Flames are not visible in windows 83-230 to 83-232, but a continuous region of fire extends from window 83-233 to window 83-245. Comparison with Figure 9-36 and Figure 9-37, taken at 9:32:24 a.m. and 9:33:53 a.m., respectively, shows that this fire had died down somewhat from the earlier times and had apparently moved one window to the west. The absence of visible fire immediately adjacent to the new fire location, along with the rapid appearance of flames at multiple windows, observations that indicate flashover took place around this time, suggests that the fire seen in windows 83-226 to 83-229 was burning within an enclosed room. It is not possible to check whether a room was present at this location since floor plans are unavailable for this floor.

**Figure 9-49.** This cropped photograph shows the north face of WTC 2 at 9:35:39 a.m. The intensity levels have been adjusted, and column and floor numbers have been added.

The fire distributions elsewhere on the north face in Figure 9-49 are similar to those in Figure 9-36 and Figure 9-37. Fires were still burning at the east edge of the tower on the 81st, 82nd, and 83rd floors. The debris piles on the 78th floor and in the lower right-hand corner of the cold spot continued to burn, and fire was visible as far west as window 79-225 on the 79th floor. A plume of smoke is visible coming from window 79-222. There are no visible indicators of fire to the west of this window on any of the floors.

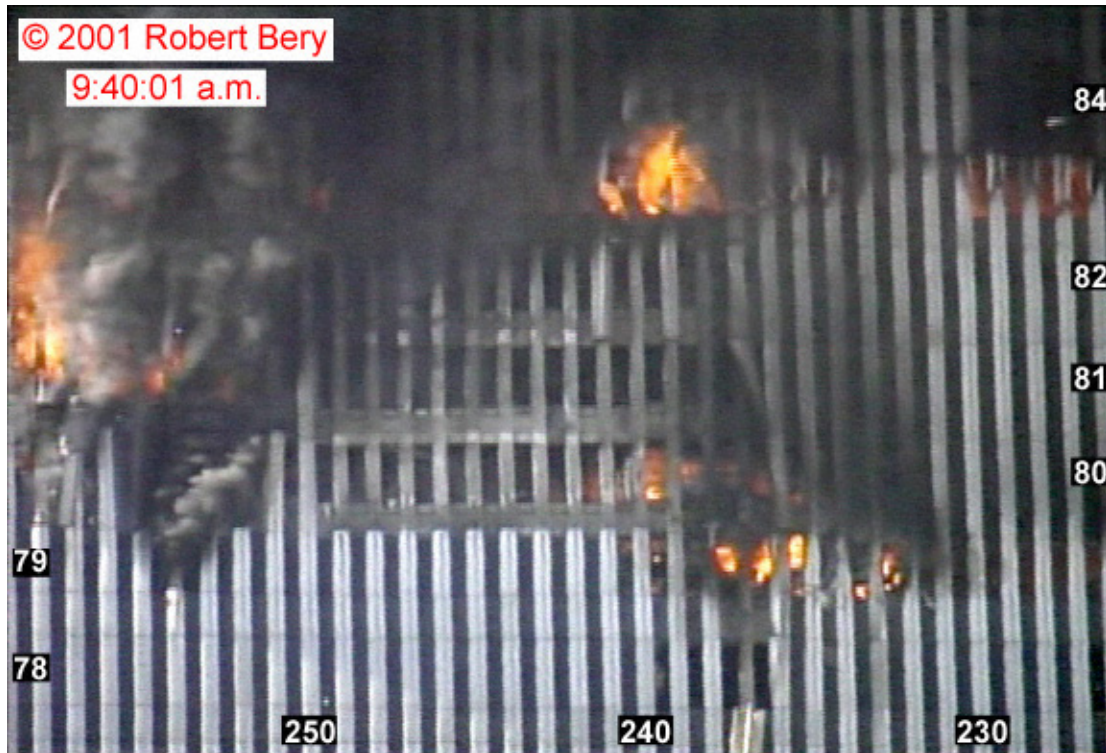
A somewhat closer view of the north face taken at 9:40:01 a.m. is shown in Figure 9-50. Even though the image contains some digital noise, it is sufficiently resolved that open and closed windows can be identified. By this time, the fire visible in windows 83-226 to 83-229 on the 83rd floor no longer had extended flames. The carets on the surrounding aluminum column covers reflect their earlier presence. The three windows immediately to the east, windows 83-230 to 83-232, appear to still have glass in place. Flames continue to extend from windows on this floor above the right-hand side of the cold spot, but flames in windows 83-234 to 83-236 have died down sufficiently that they are no longer visible. Carets around these windows indicate that extended flames were present earlier. The fire on the eastern edge of the 81st floor continues to burn vigorously, hiding the locations immediately above on the 82nd and 83rd floors. The fires burning on piles of debris on the 79th and 80th floors have comparable intensities to those seen in recent images.

**Figure 9-50. This frame captured from a video shows the north face of WTC 2 at 9:40:01 a.m. The intensity levels have been adjusted, and column and floor numbers have been added.**

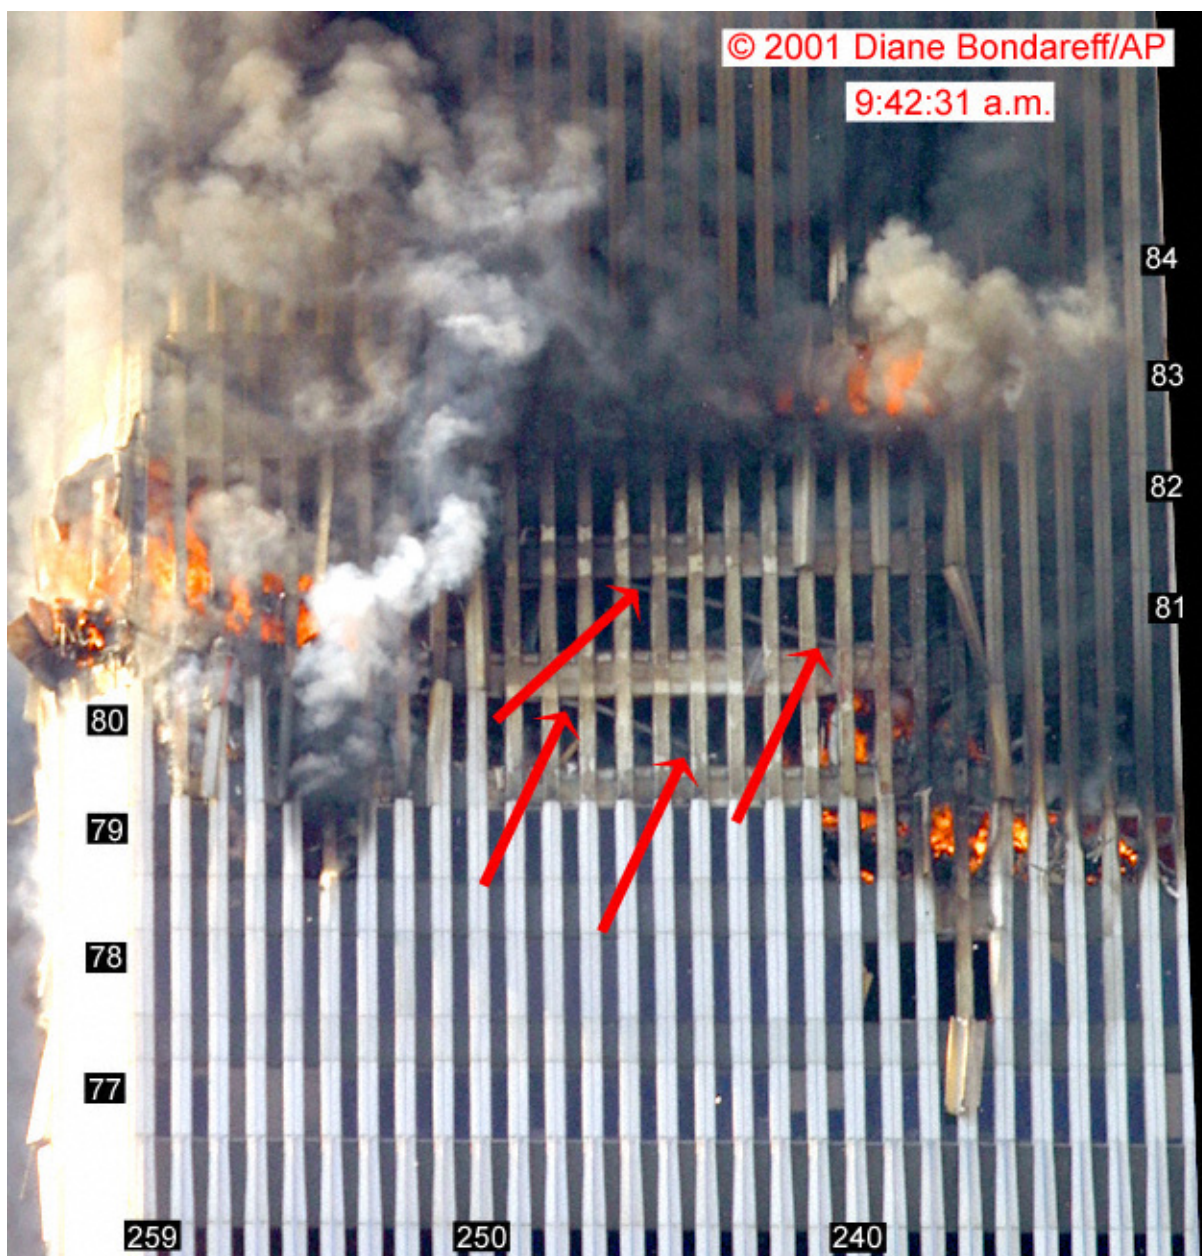
A high-resolution photograph of the area around the cold spot on the north face is reproduced in Figure 9-51. It was shot at 9:42:31 a.m. Arrows have been added to the image to indicate hanging objects that are visible through open windows on the 80th and 81st floors. The area containing the arrows is blown up further in Figure 9-52. It is instructive to compare this image with Figure 9-17, which shows a blowup of roughly the same area at 9:14:03 a.m., and Figure 9-12, which was recorded at 9:10:01 a.m.

**Figure 9-51.** This cropped photograph shows a portion of the north face of WTC 2 at 9:42:31 a.m. The image has been rotated and enhanced by adjusting the intensity levels, and column and floor numbers have been added. The arrows highlight hanging objects visible through open windows on the 80th and 81st floors.

Figure 9-51 provides good views of the fires that continued to burn on the east edge of the north face on the 81st and 82nd floors and on the piles of debris on the right side of the cold spot on the 79th and 80th floors. Flames are also visible on the 83rd floor in windows 83-238 to 83-244. All of these fires have similar appearances to those seen in recent earlier photographs.

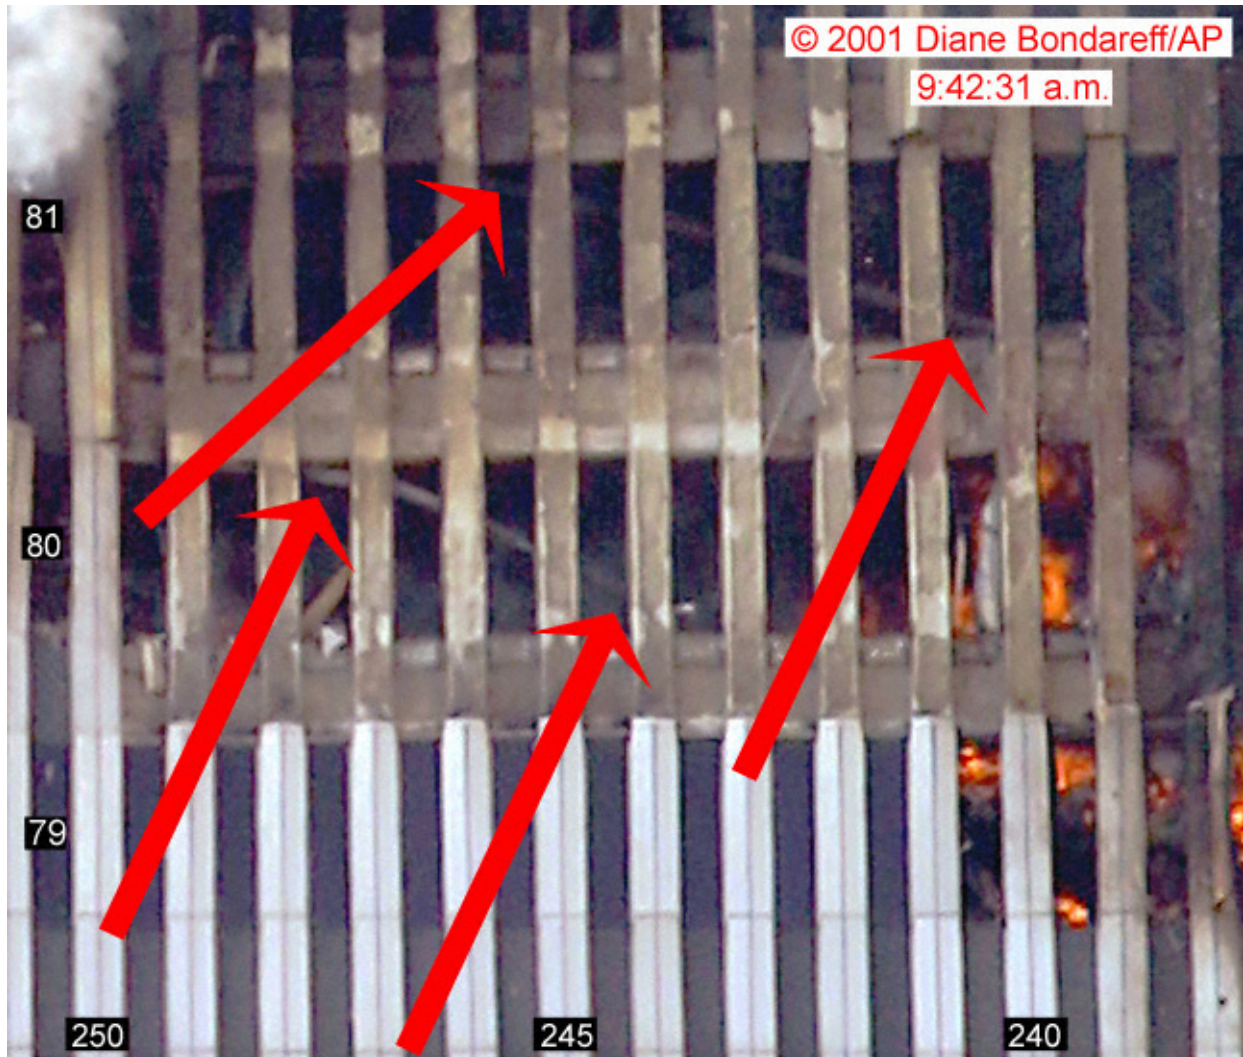
Hanging objects are visible in the two blow-ups shown in Figure 9–17 and Figure 9–52, but it is apparent that their locations and appearances have changed between the times when the two photographs were taken. At the earlier time, two objects were observed through open windows in the cold spot on the 80th floor. The first was located near the center of the windows and extended across the entire area, reaching as far east as window 80-255. The second was visible curving downward in window 80-247 and extending to near the center of window 80-242. In Figure 9–52 the lower object has apparently disappeared completely from view, and the object that was hanging higher up in the windows has dropped down. It now first appears in window 80-248 and curves rapidly downward, seeming to disappear below the spandrel at the base of window 80-243.

In the earlier blow-up there appeared to be two objects hanging in the cold spot on the 81st floor just below the tops of windows 81-239 to 81-242. In Figure 9–52 only a single object is visible through windows in this area of the 81st floor. It now first appears in window 81-245 and curves downward to the base of window 81-240. This object has also apparently shifted position.

Recognizing that the appearances of the hanging objects changed to such a large extent between 9:14 a.m. and 9:42 a.m., lower-resolution images, in which the objects were not well resolved, taken between these times were reviewed. In many of these images there are faint indications of the hanging objects, and it proved possible to narrow down the times when the changes occurred. In Figure 9-32 the objects are barely visible on the 80th and 81st floors at 9:27:04 a.m. Their locations are consistent with those seen in Figure 9-17 on both floors. This is no longer true in Figure 9-35. On the 80th floor the faint hanging object appears to have the same shape as in Figure 9-52, while on the 81st floor the hanging object seems

to be close to the top of the windows. These observations indicate that changes in the location of the hanging objects took place between 9:27:04 a.m. and 9:29:42 a.m. on the 80th floor and sometime between 9:29:42 a.m. and 9:42:31 a.m. on the 81st floor.

**Figure 9-52.** A section of the image shown in Figure 9-51 is blown up. The arrows point to the locations of hanging objects that are visible through open windows on the 80th and 81st floors on the north side of WTC 2. Column and floor numbers have been added.

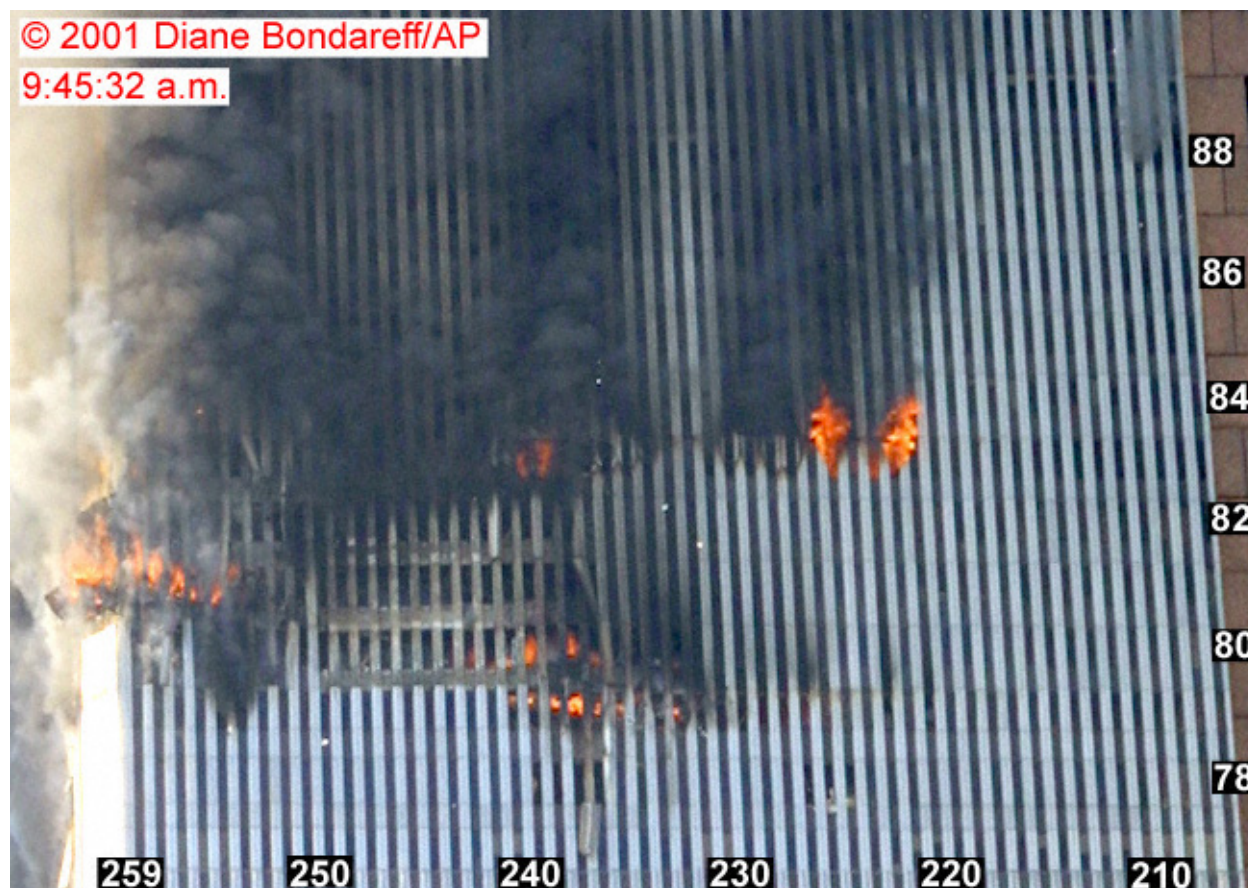
A video shows that a stream of smoke appeared from window 83-224 on the 83rd floor of the north face at 9:42:26 a.m., and a small object (window glass?) fell from the location at the same time. Twenty-seven seconds later, the smoke plume burst into flames. At 9:45:02 a.m. there was another burst of smoke and a falling object from window 83-222, followed by flames 5 s later. This flame spread to window 83-221 at 9:45:25 a.m. A photograph face taken 7 s later is shown in Figure 9-53. Two long tongues of flames are

coming from windows 83-221 and 83-224. Flames are no longer visible in windows 83-226 to 83-230, even though carets are visible on adjacent column covers. Windows 83-225, 83-231, and 83-232 appear to have glass in place. The sudden and isolated development of a fire on the 83rd floor in windows 83-221 to 83-224 suggests again that flashover within a room has occurred. The fire on this floor near the left edge of the cold spot has died down with internal flames only visible in windows 83-238 and 83-239.

**Figure 9-53.** This image of the north face of WTC 2 was taken at 9:45:32 a.m. The photograph has been cropped and rotated, and the intensity levels have been adjusted. Column and floor numbers have been added. The brown area to the right is the eastern edge of WTC 7.

The fire burning on the eastern edge of the north face on the 81st floor continues to burn vigorously, but flames are not visible in the 82nd floor windows at this time. A small fire is visible in window 83-259 on the 83rd floor. The fires on the 79th and 80th floors near the center of the north face continue to burn on the piles of debris. Fires are not evident on the 79th floor to the west of window 79-230, even though smoke marks and open windows at 79-220 and 79-222 are evidence of the earlier burning observed in this area.

In Figure 9-53 an isolated smoke plume is visible on the 88th floor coming from window 88-208. This is another location where it is possible that people have broken out a window. A photograph shot just before 9:45 a.m. showed that windows 88-201 to 88-203 were also open.

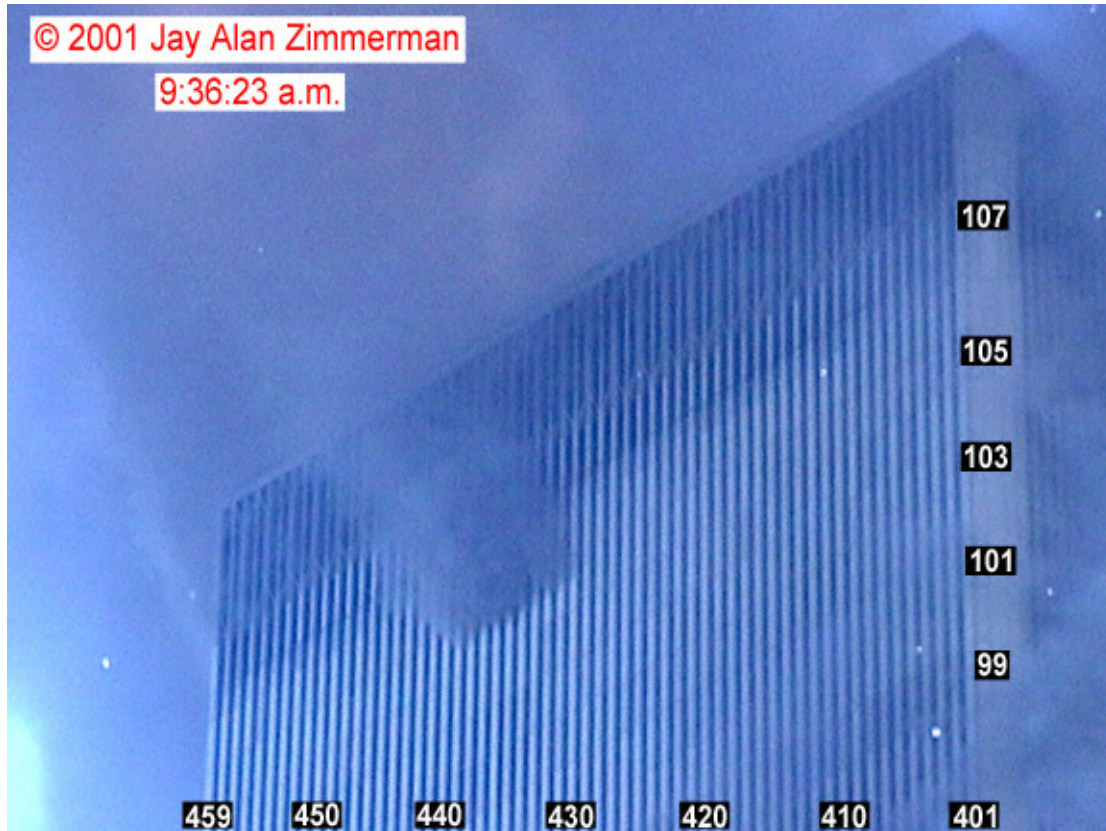
Clear close-up images of the fires on the south face of WTC 2 are limited between 9:30 a.m. and 9:38 a.m. Figure 9–54 shows a frame taken from a video of the upper portion of the south face at 9:36:23 a.m. It has been included because at this time the smoke on the face cleared sufficiently to observe that heavy smoke was coming from multiple windows, extending from roughly window 105-430 to window 105-438, on the 105th floor. This is another location where people may have broken open windows. This was the only location above the fire floors where smoke flow from open windows was evident on this face. In particular, no smoke was observed flowing from the upper mechanical equipment room floors.

**Figure 9-54.** This image is taken from a video shot from the southeast and shows the upper portion of the south face of WTC 2 at 9:36:23 a.m. The intensity levels have been adjusted, and column and floor numbers have been added.

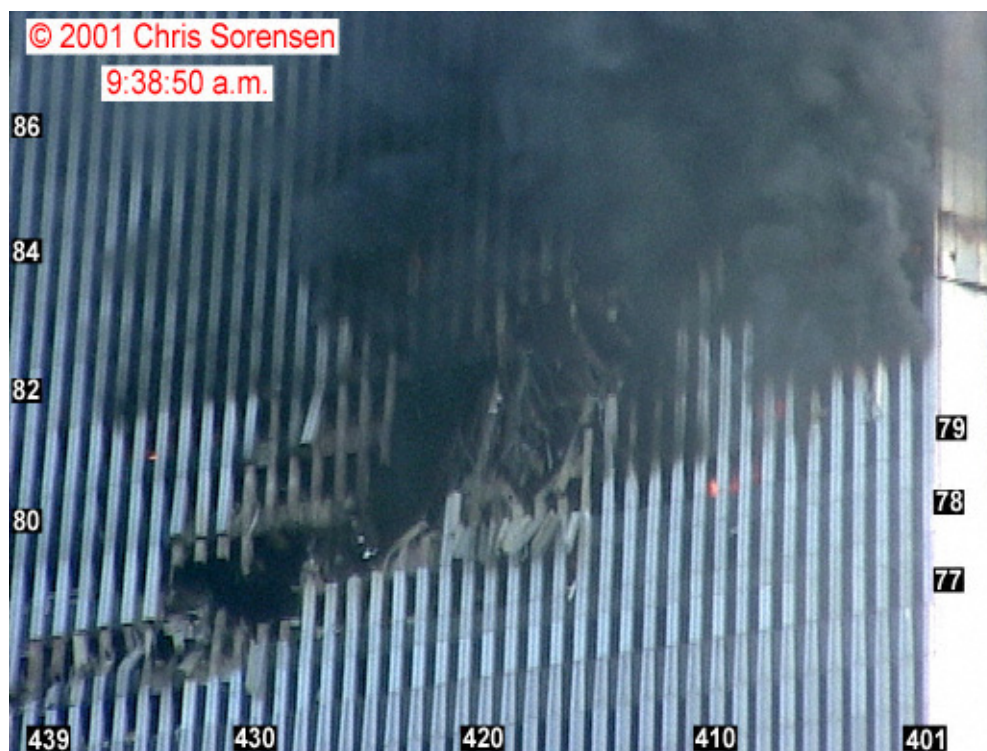
A video shows that heavy smoke began flowing from windows at the eastern edge of the south face on the 80th floor at 9:38:12 a.m. This smoke is visible coming from windows 80-401 to 80-408 in Figure 9–55, which shows a frame captured from a video recorded at 9:38:50 a.m. In the video, fire, which is visible inside windows 80-407 and 80-408, occasionally extended from these windows. The smoke coming from the 80th floor tended to hide the windows on the floors immediately above, but there were brief glimpses of a fire burning on the 83rd floor.

Comparison of Figure 9–55 with Figure 9–41, which was taken roughly 8½ min earlier, shows that changes in fire locations and intensities have taken place on the south face. In comparing the images it should be kept in mind that Figure 9–55 was shot from further east and, as a result, low intensity fires are likely to be hidden by columns. With this caveat in mind, it is clear that the large fire visible in windows 81-431 to 81-435 to the left of the aircraft impact cavity in Figure 9–41 has died down. In Figure 9–55

only a small spot fire is visible near the bottom of window 81-435. On the 79th floor, flames are no longer evident near window 79-426, but the fire has migrated to the east from this area, and burning is now visible in windows 79-408 to 79-410.

**Figure 9-55.** This image of the south face of WTC 2 was captured from a video recorded at 9:38:50 a.m. The intensity levels have been adjusted, and column and floor numbers have been added.

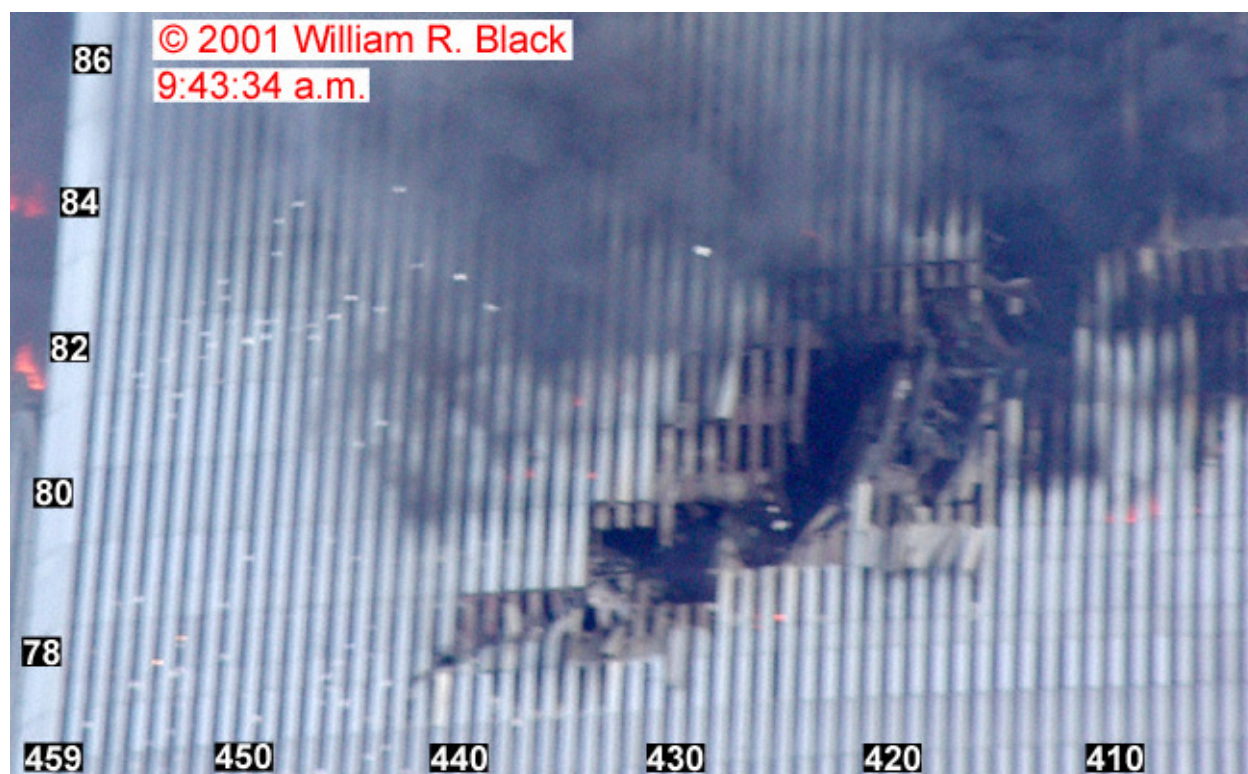
Another view of the south face taken at 9:43:34 a.m. is shown in Figure 9-56. More widespread flames are visible than in Figure 9-55 because it was shot from a location more directly to the south and further away. Low intensity fires are visible on the 80th and 81st floors to the west of the aircraft impact cavity. The fire on the 81st floor is a remnant of the intense fire seen in this area at 9:30:19 a.m. (see Figure 9-41), while the fire on the 80th floor has been burning at a low level since at least 9:23 a.m. (see Figure 9-26). A small fire, which has been burning on the 78th floor just to the east of the aircraft impact cavity since shortly after the impact, is also evident.

The fire on the east side of the 79th floor in windows 79-408 to 79-410 in Figure 9-55 was also present at 9:43:34 a.m., and there is now an indication of flame at window 79-406. The heavy smoke and fire present on the 80th floor at 9:38:50 a.m. seem to have dissipated, and it is possible to see the base of the 83rd floor on the eastern edge. Videos suggest that this change occurred around 9:40 a.m. There are now no flames visible east of the aircraft impact cavity on the 80th through 82nd floors as far east as column 404, which is the last column visible in the image.

**Figure 9-56.** This cropped, slightly out of focus photograph of the south face of WTC 2 was shot at 9:43:34 a.m. The intensity levels have been adjusted, and column and floor numbers have been added. The flames visible to the left of the western edge of WTC 2 are on the south side of WTC 1.

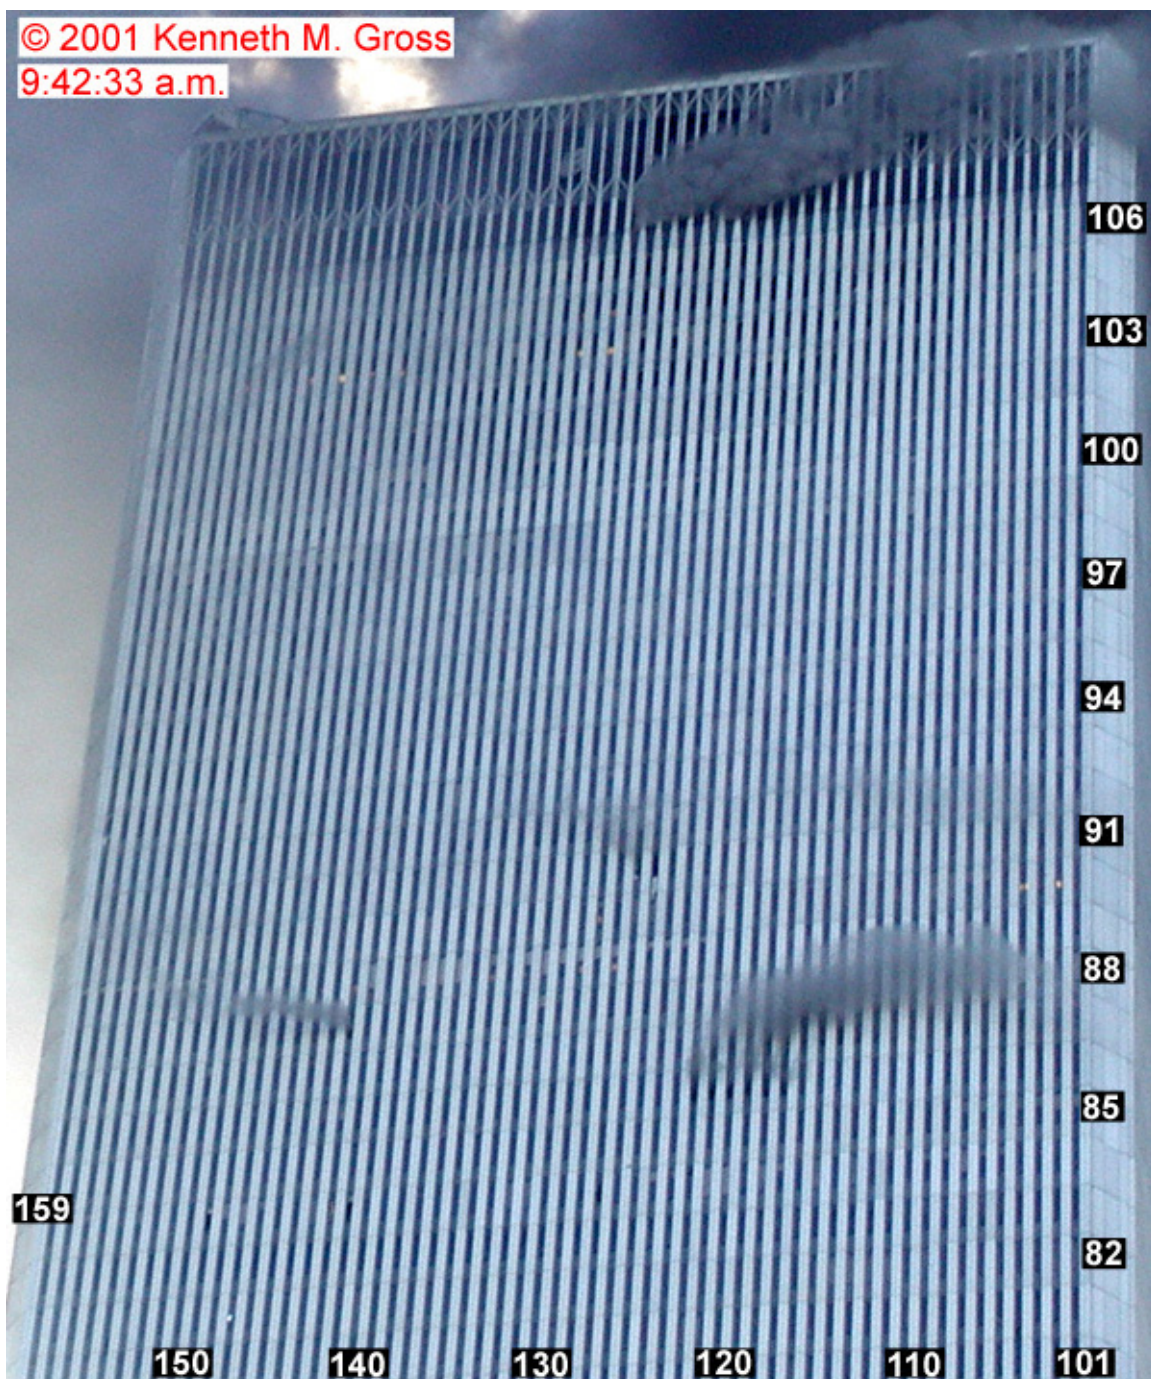
A clear view of the west face of WTC 2 at 9:42:33 a.m. is shown in Figure 9-57. Smoke is visible coming from several windows on the 86th, 88th, 91st, 105th, and 107th floors, as well as from the mechanical equipment room on the 108th and 109th floors. These locations include windows 86-117 to 86-122, 88-142, 91-125 and 91-126, 105-148, 107-123 to 107-129, and the two right-most windows on the 108th floor. Smoke was observed coming from these same locations at 9:34:19 a.m. (see Figure 9-42), with the exception of the windows on the 91st and 105th floors. These two locations had light smoke flows, and it is difficult to determine when the windows were opened.

In Figure 9-42 smoke was also coming from a window, 84-149, on the 84th floor. Smoke is not visible at this location in Figure 9-57, but the image has sufficient resolution to confirm that this window was open. Windows 84-141 and 84-127 also appear to be open on this floor. It is interesting that no smoke seems to be flowing from the open windows that are located closest to the fire floors. No other open windows are apparent on lower floors (note that the image from which Figure 9-57 was cropped extended as far down as the mechanical equipment room on the 76th floor).

On several floors electric lights are visible through windows on the west face in Figure 9-57. These include the 104th floor. The fact that lights remained on for floors well above the aircraft impact floors means that the aircraft did not cut all of the power lines running to the top of the tower as it passed through the core.

**Figure 9-57.** This cropped photograph shows the west face of WTC 2 at 9:42:33 a.m. It has been rotated and enhanced by adjusting the intensity levels. Column and floor numbers have been added.

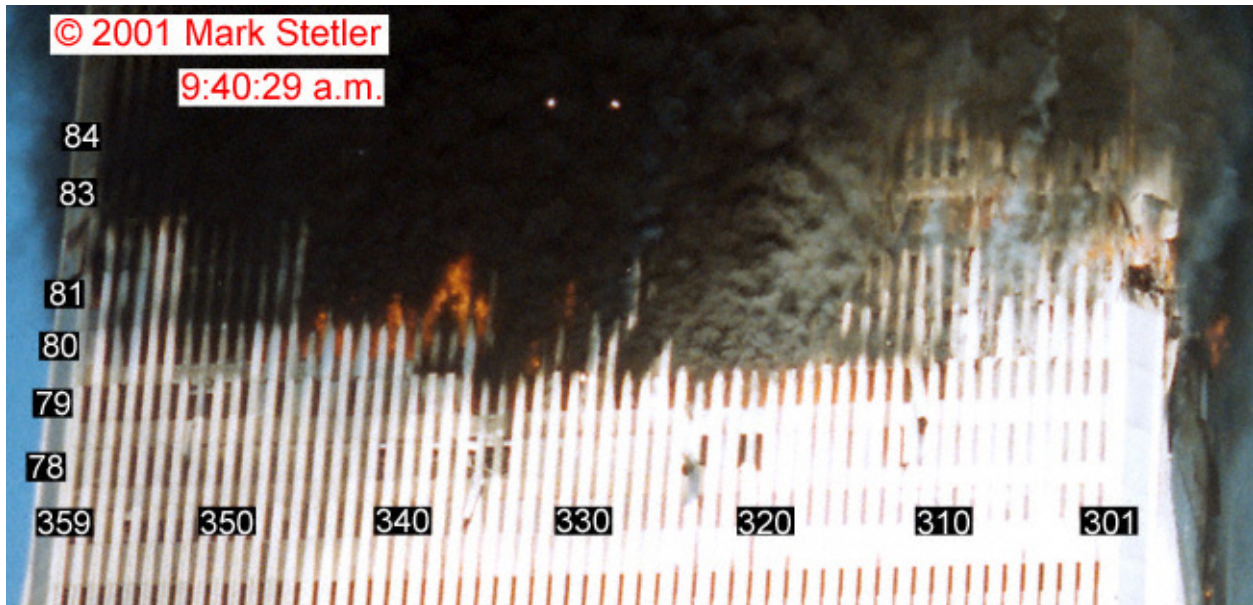
Fires are visible in Figure 9–58 on the 79th and 80th floors at roughly the same locations as in the photograph shown in Figure 9–43 and Figure 9–44, which was taken at 9:36:14 a.m. The fires are particularly heavy on the 80th floor near windows 80-331 to 80-339. The duration (roughly 50 s) of the heavy smoke flows and fires is comparable to that of the earlier event observed between 9:35:45 a.m. and 9:36:50 a.m. This suggests that the cause for the short-lived burning is the same. Therefore it is also tentatively attributed to the burning of a pool of aviation fuel somewhere inside the tower.

**Figure 9-58.** This cropped photograph showing the east face of WTC 2 was taken at 9:40:29 a.m. Column and floor numbers have been added.
